**CWA COMPLIANCE EVALUATION INSPECTION REPORT
U.S. ENVIRONMENTAL PROTECTION AGENCY, REGION 5**

Compliance Evaluation Sampling Inspection

Walworth County

November 17, 2015

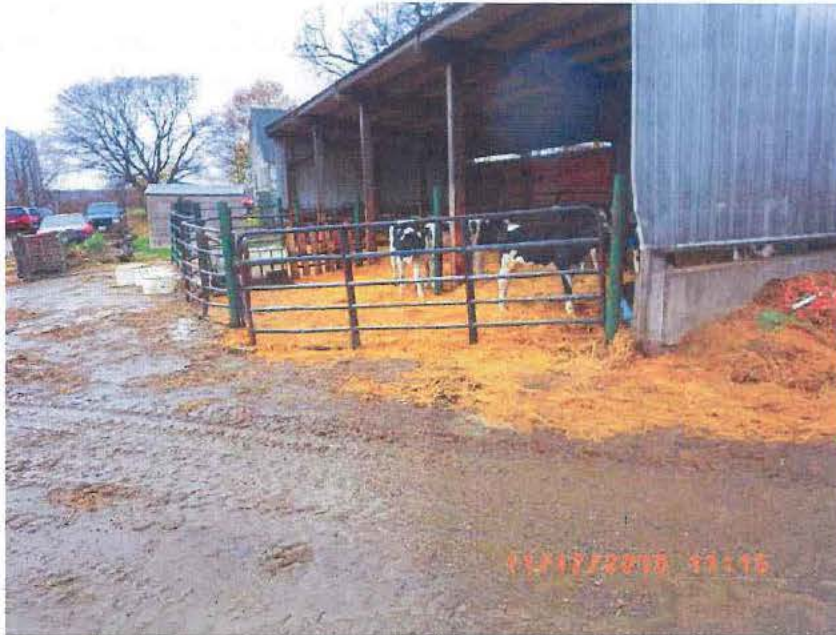
1: RIMG0553

The Calf Barn and its open pen do not have any containment for manure, feed, or process wastewater. These can flow with precipitation to the south along the facility's access road. EPA observed brown leachate in the puddles of water on the access road.

Description: No containment for feed, manure, or process wastewater from the Calf Barn, which can flow with precipitation to the south.

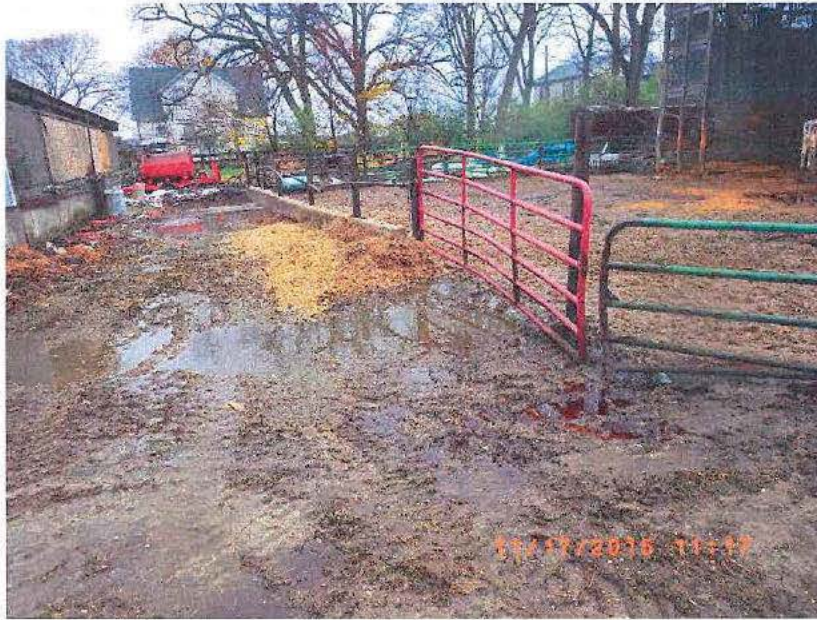
2: RIMG0554

Description: Open pen for a barn north of the Calf Barn. The pen does not have containment for feed, manure and process wastewater, which can flow with precipitation to the south. EPA observed a plume of process wastewater in the puddles outside the pen.

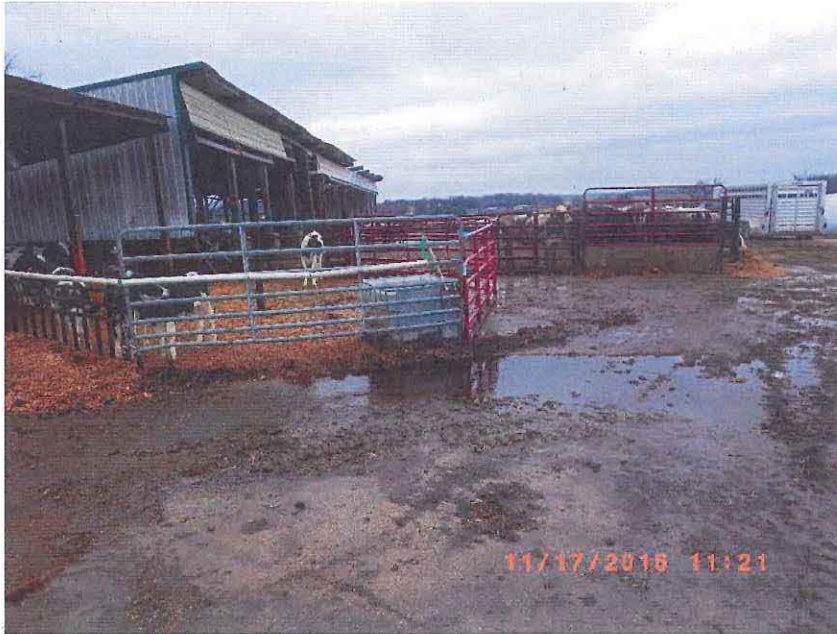
7: RIMG0559

The Heifer Barn to the west of the Silage Pad also did not have containment for manure, feed or process wastewater from the animals confined in this barn. EPA observed plumes of polluted process wastewater in the standing water outside these pens, which would flow to the south with precipitation. Some manure and feed was pushed out of the north side of the open pen and EPA noted that there was process wastewater in the standing water outside the pen. This water did not appear to be able to reach a surface waterway because there was a rise in elevation in the land to the north.

Description: Open pens around the heifer barn do not have any containment for feed, manure, or process wastewater. EPA observed plumes of process wastewater in the puddles around the pens.

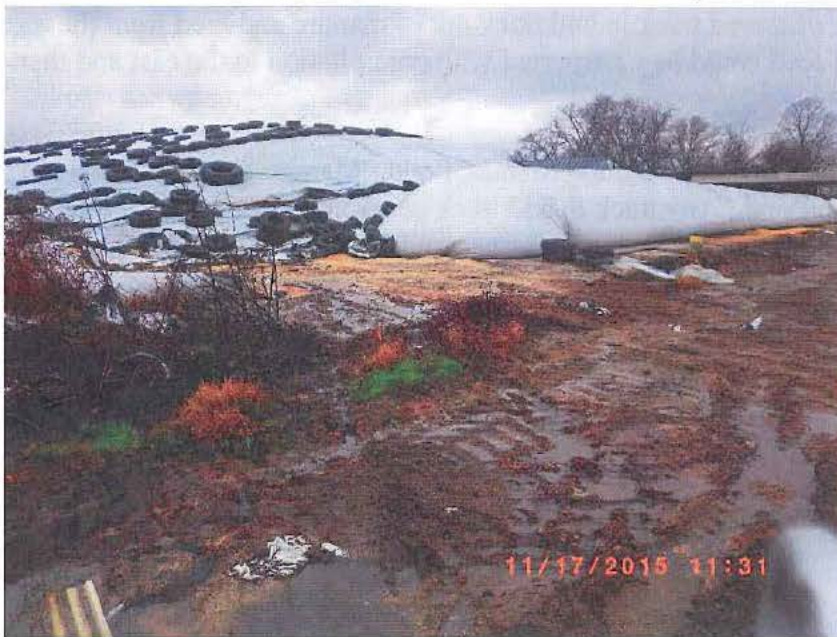
19: RIMG0571

Description: EPA observed spilled feed and process wastewater from spilled feed on and around the Silage Pad.

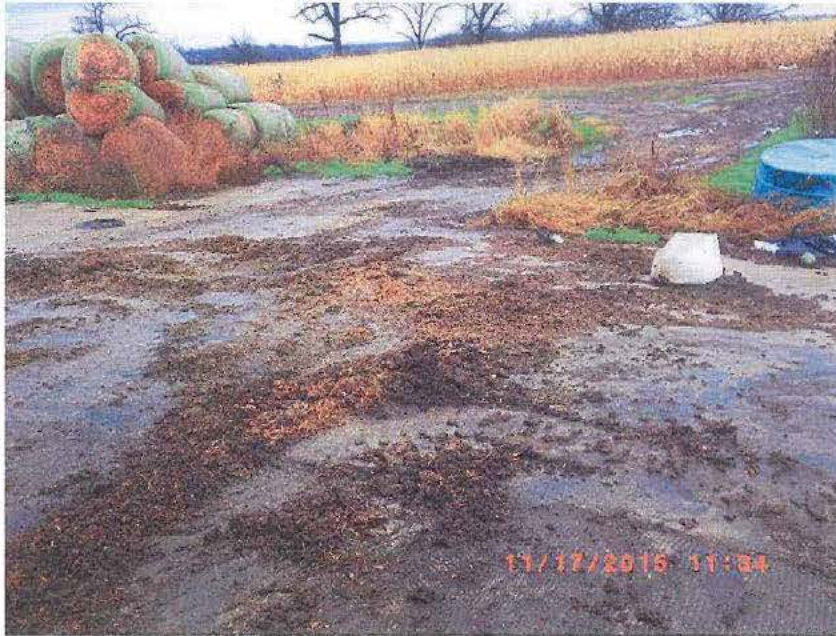
21: RIMG0573

At the 2010 Freestall Barn, EPA observed track in and track out of manure and feed from the northeast door. The manure and feed could be transported with precipitation to the east and then south.

Description: Track in and track out of manure and feed at the northeast end of the 2010 Freestall Barn. The manure and feed could be transported with precipitation to the east.

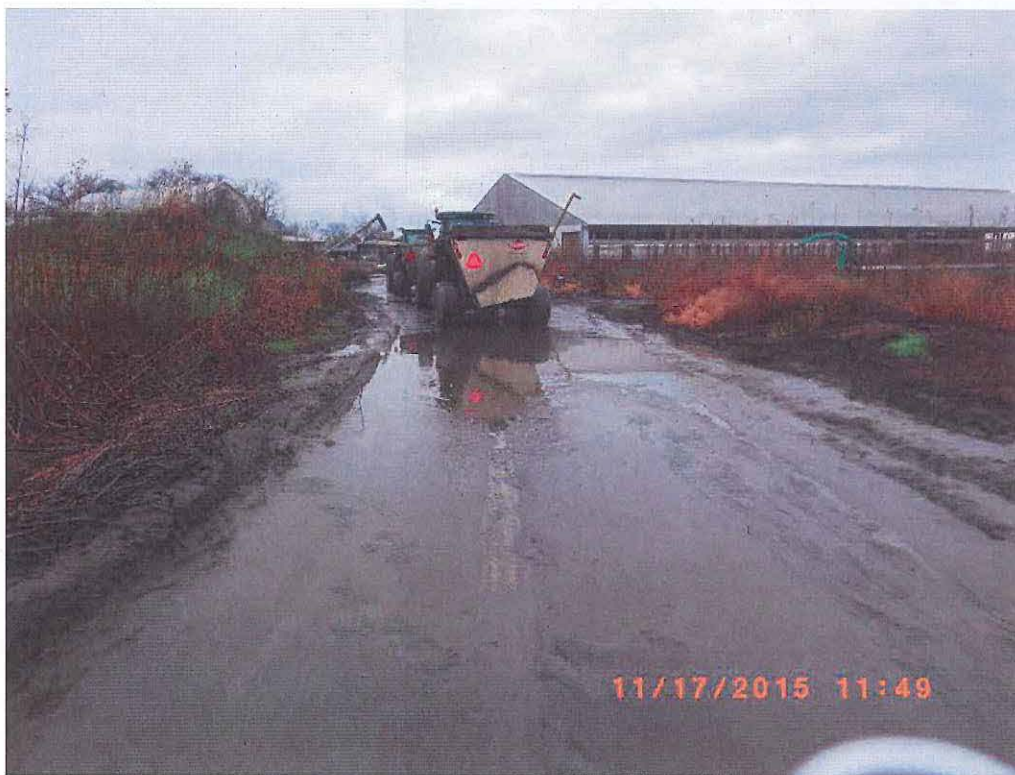
29: RIMG0581

Description: Manure application equipment in access road that leads to crop field so the south. This access road is concrete with berms on either side. Manure slurry on the access road was several inches deep. Facility owners stated that the manure can be scraped back to the Manure Pond. EPA did not observe any runoff from this access road to a surface water.

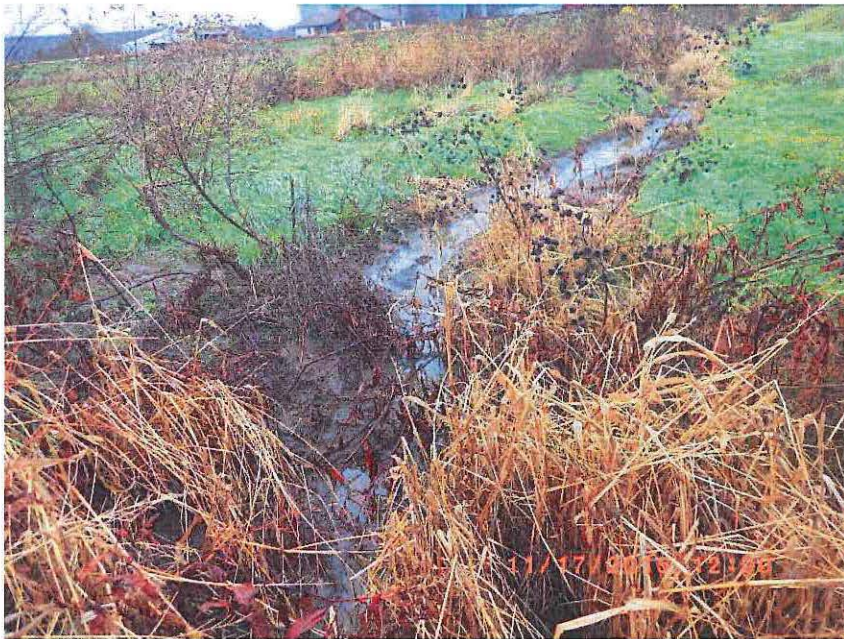
37: RIMG0589

Just to the southwest of the 2004 Freestall Barn, EPA observed a channel conveying flow from the north. EPA followed the channel up the yard to the north and observed that the flow contained process wastewater from the open pens on the west side of the 2000, 2002, and 2004 Freestall Barns. There was no containment for manure, feed and process wastewater from the west doors of the barns or from their open pens. Precipitation from the north part of the production area, north of the Milking Parlor, also would flow along the facility access roads and eventually to this channel. Note that EPA observed no containment for manure, feed and process wastewater from the Calf Barn, the Heifer Barn and its open pen and the Silage Pad.

Description: A channel of flow comes from the north and flows to the south and into the drainage ditch before flowing west.

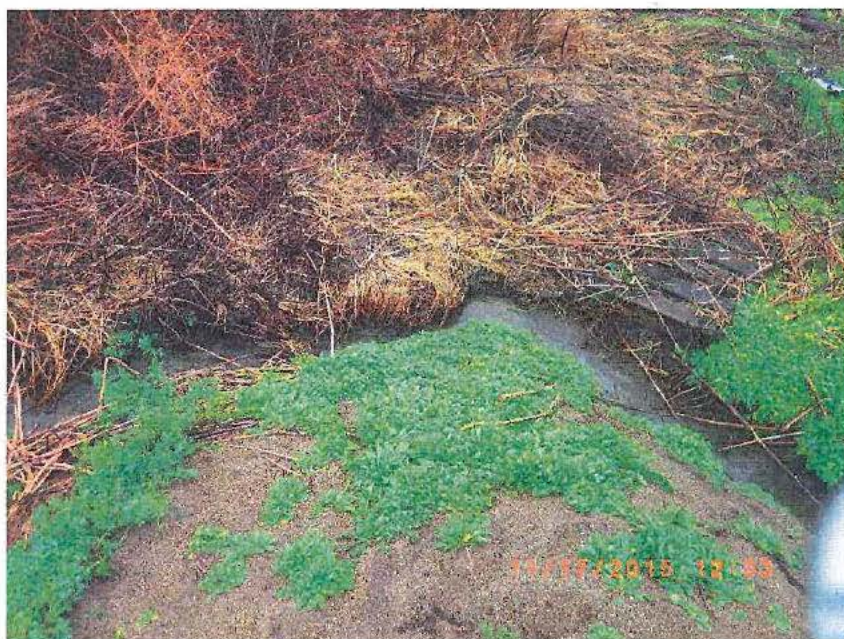
45: RIMG0597

Description: EPA observed flow in the channel the whole length from the drainage ditch up to the access road.

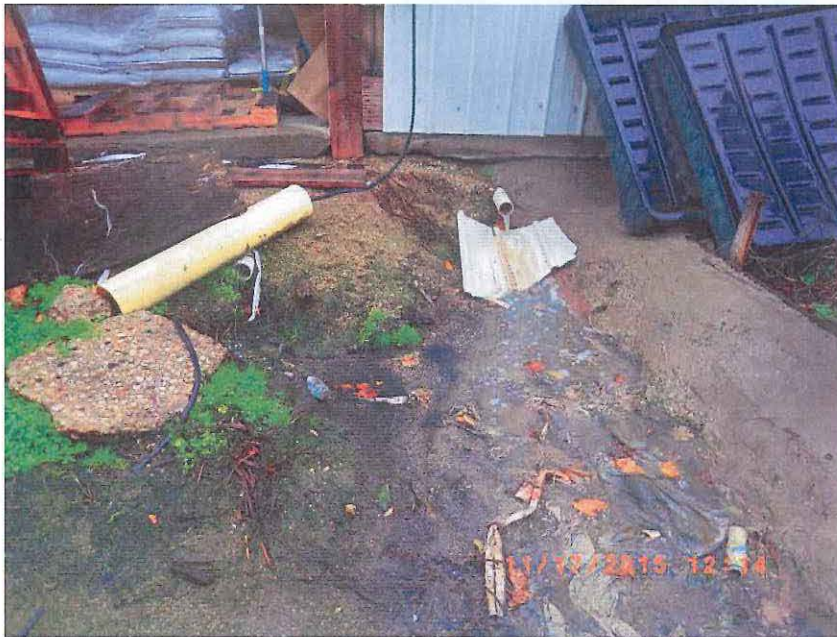
58: RIMG0610

EPA observed three pipes in the space between the 2000 Freestall Barn and the Milking Parlor. The pipes discharge storm water from various locations. One pipe is connected to the area where the milk truck parks, one is connected to a sump pit for storm water inside the Milking Parlor and one is from roof water and is tied to a downspout.

Since this water flows along the ground where there is manure, feed and process wastewater, it aids in the transport of those pollutants to the channel and then to the drainage ditch.

Description: Pipes discharge storm water from where the milk truck loads and from the sump pump for storm water in the Milking Parlor.

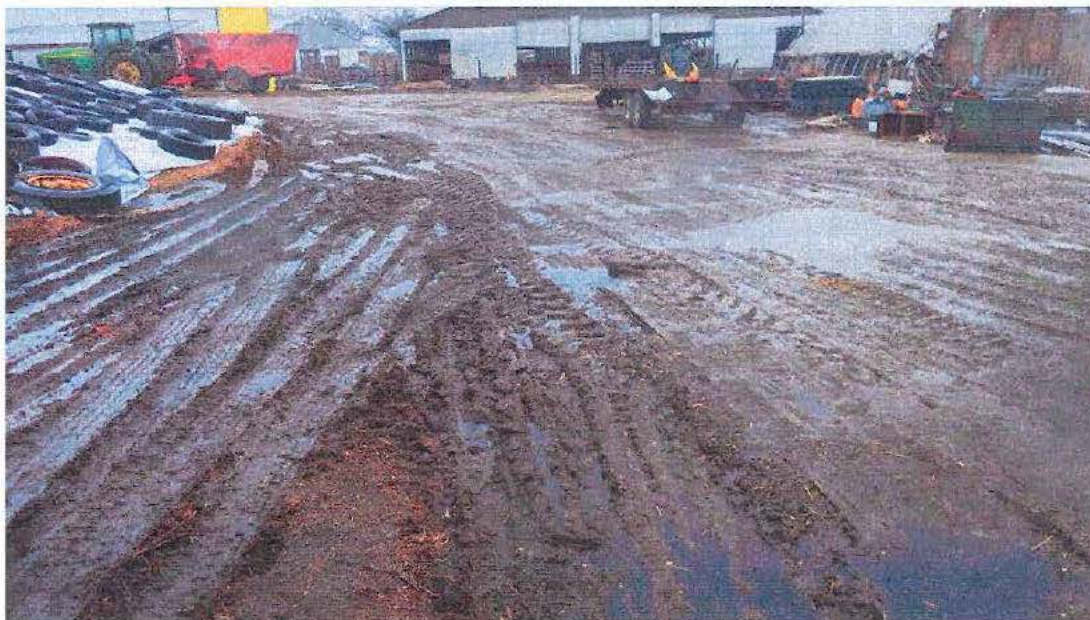
63: RIMG0615

Some of the spilled feed in the feed mixing area flowed to the south in a different pathway, one that flowed between the calf hutches and the building to the west. EPA noted that the standing water was dark colored and truck tire ruts assisted the flow by creating channels. At times, there was not any flow, but the vegetation along the pathway appeared to be nutrient burned and the nutrient burned vegetation led to the drainage ditch.

Description: Feed mixing area has spilled feed on the ground that can be transported with precipitation.

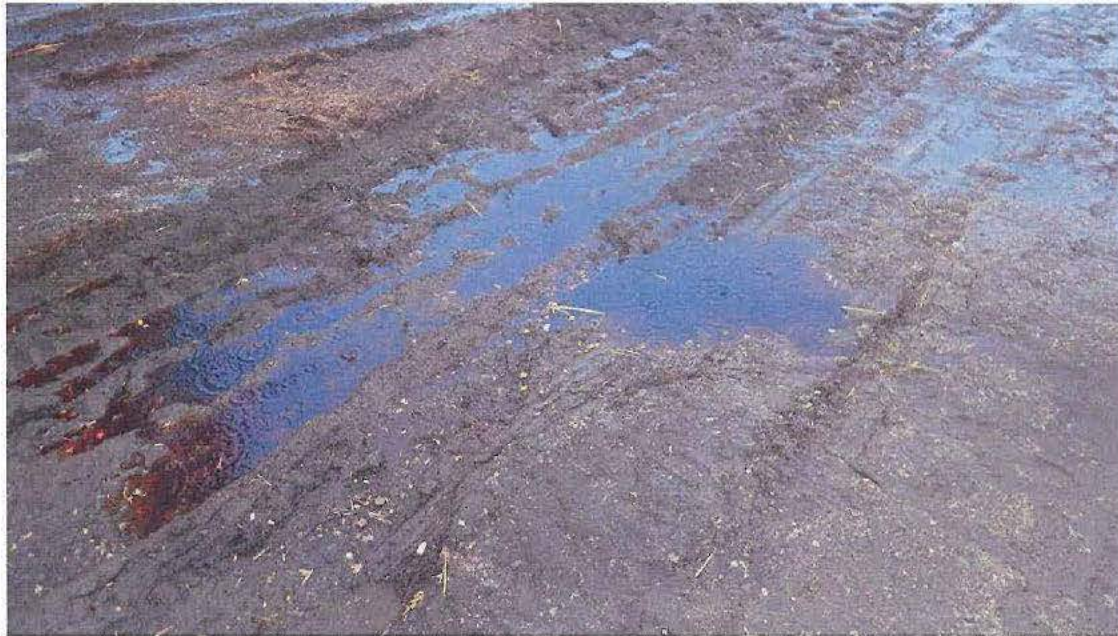
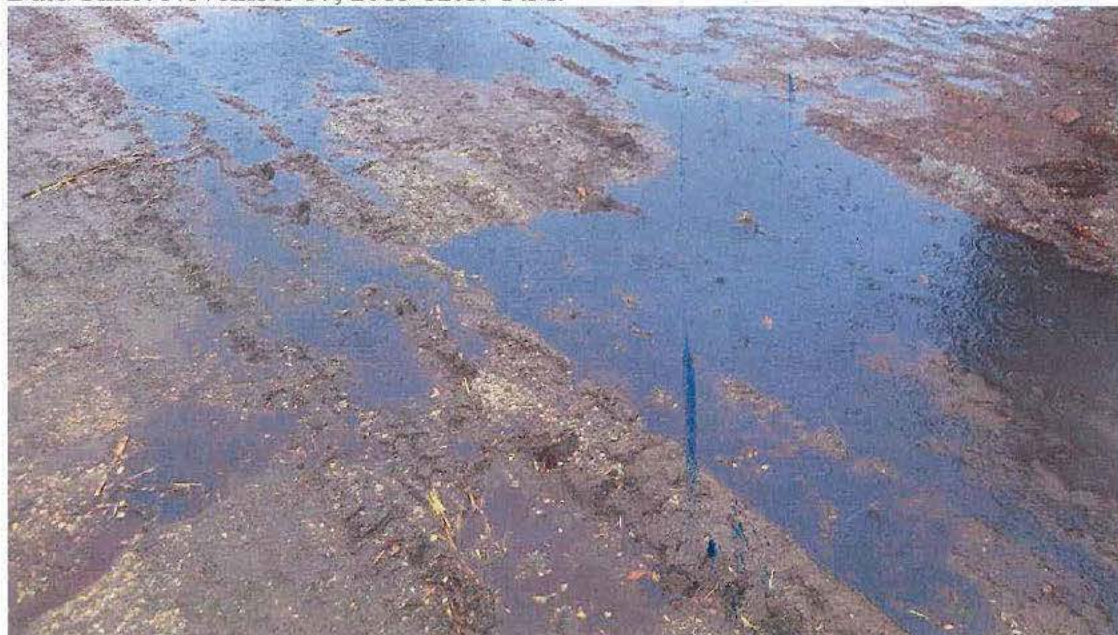
Description: Process wastewater was observed in the water on the ground. Water is dark brown.

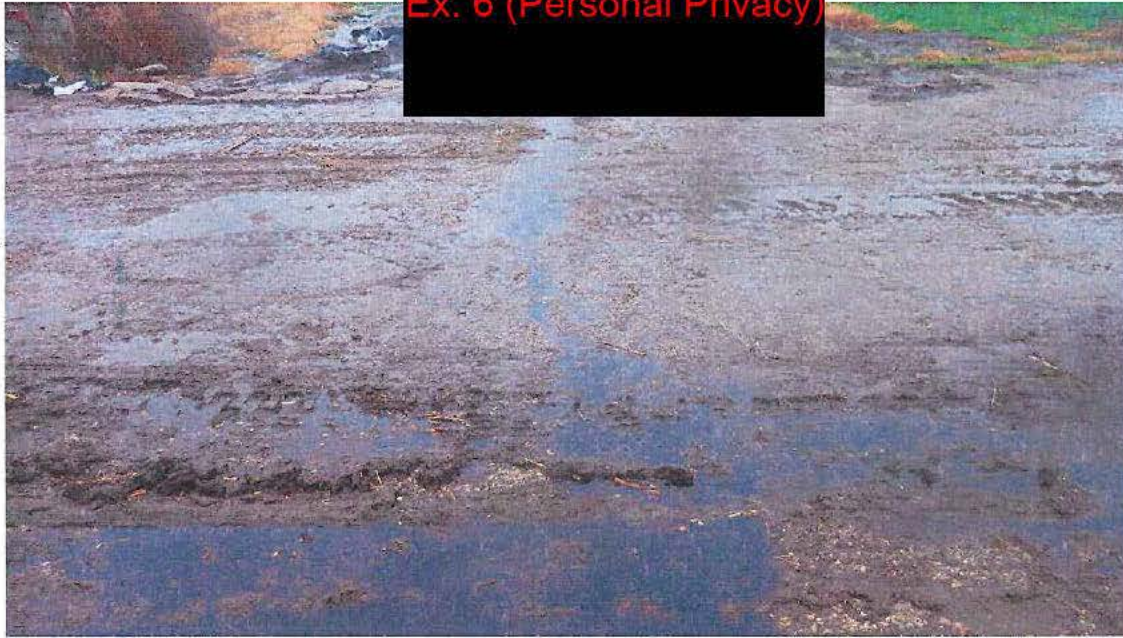
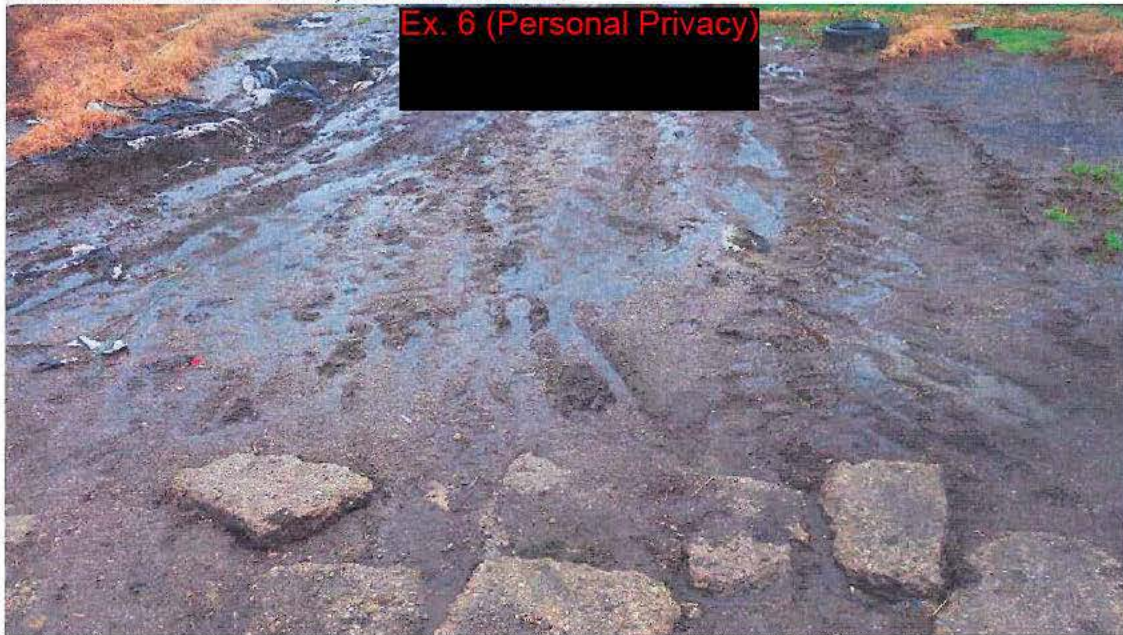
Description: Process wastewater was observed in the water on the ground. Water is dark brown and plume of process wastewater was observed in the flow channels.

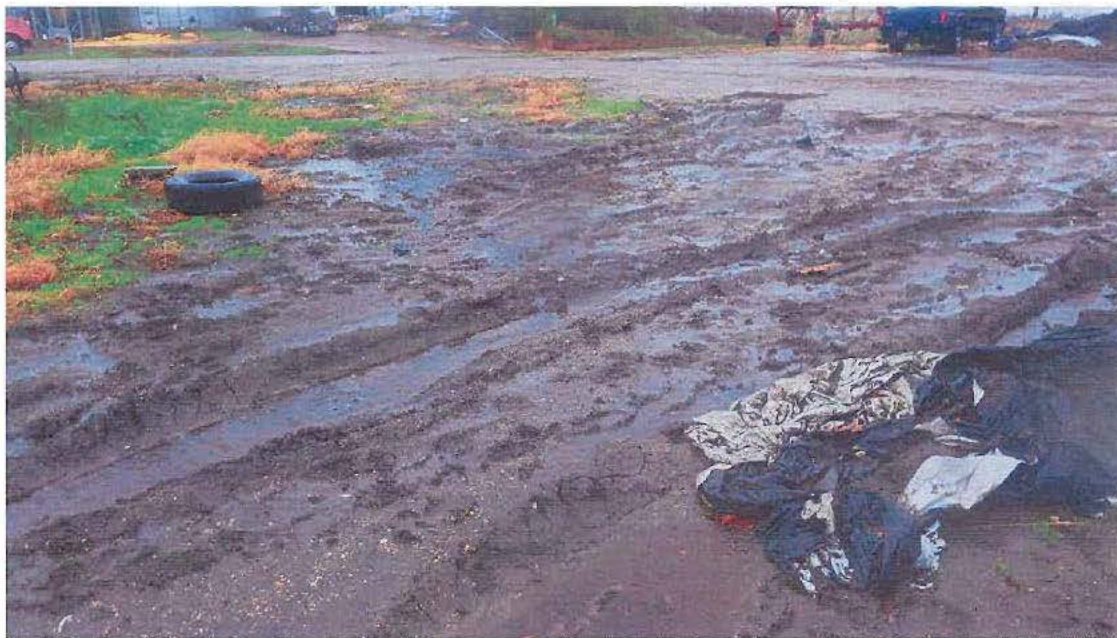
68: RIMG0620

Description: The flow channels from the mixing area flowed to the south, west of the calf hutches.

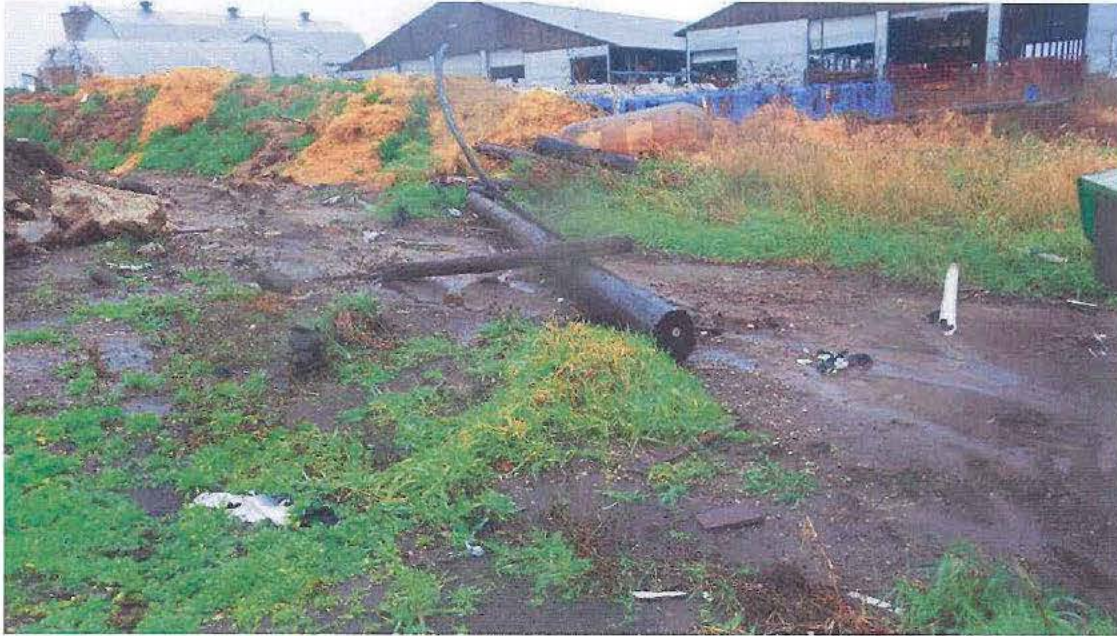
72: RIMG0624

Used bedding from the calf hutches was piled on the west side of the calf hutch area and leachate of process wastewater from the used bedding would flow with precipitation to this pathway.

Description: Used straw from the calf hutches was piled west of the hutches. Manure and process wastewater from the used straw could flow with precipitation to the south.

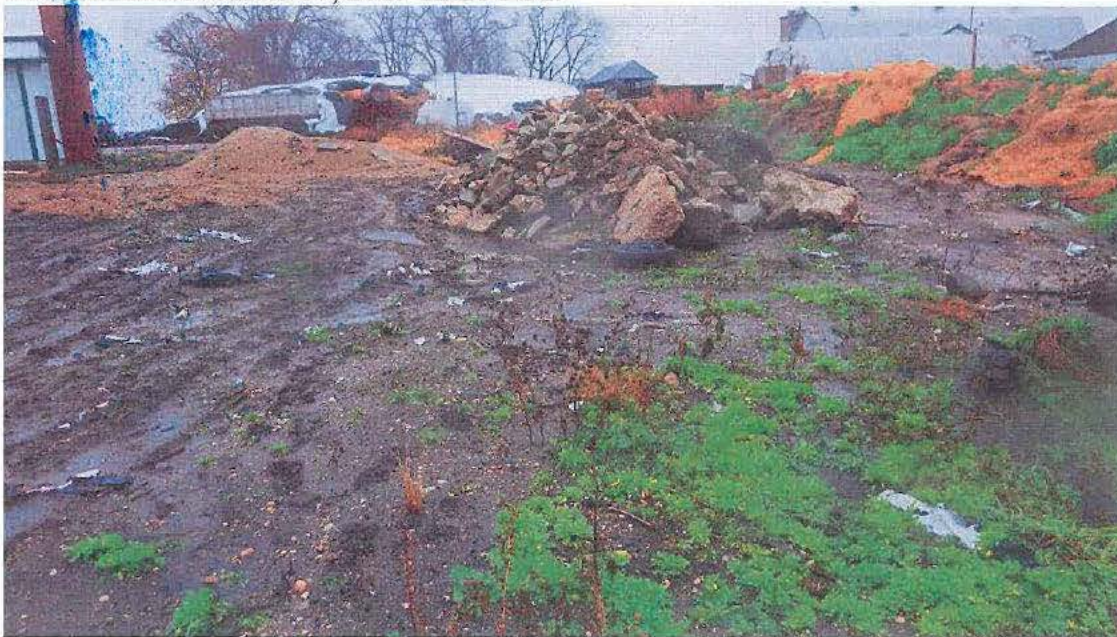
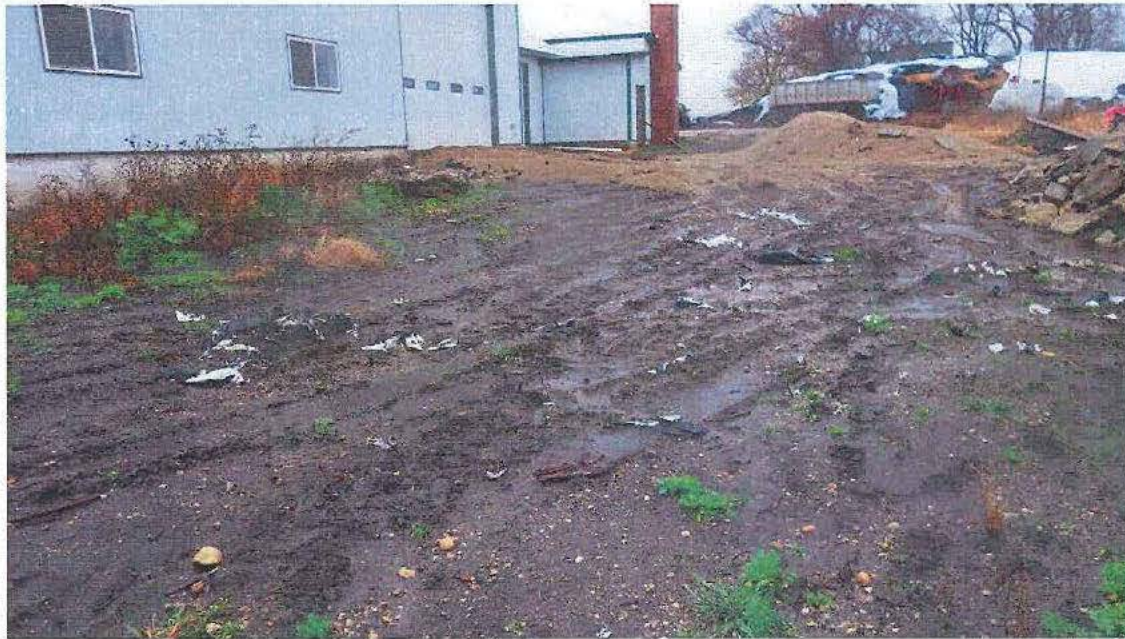
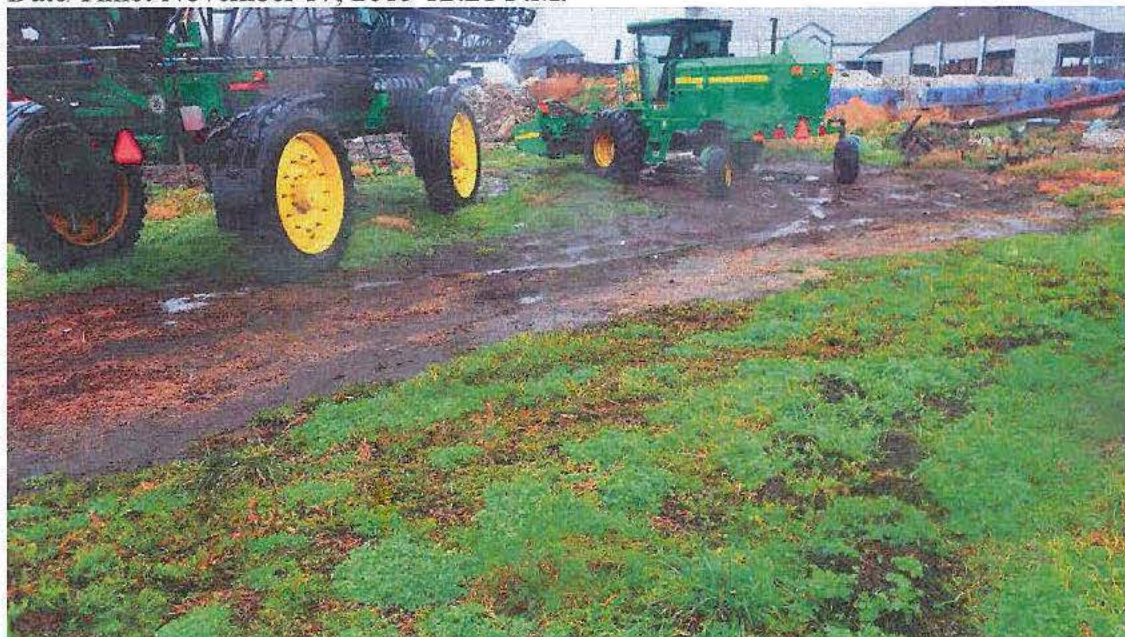
Description: Flow channelization in the yard west of the calf hutches showed that stormwater flowed to the south.

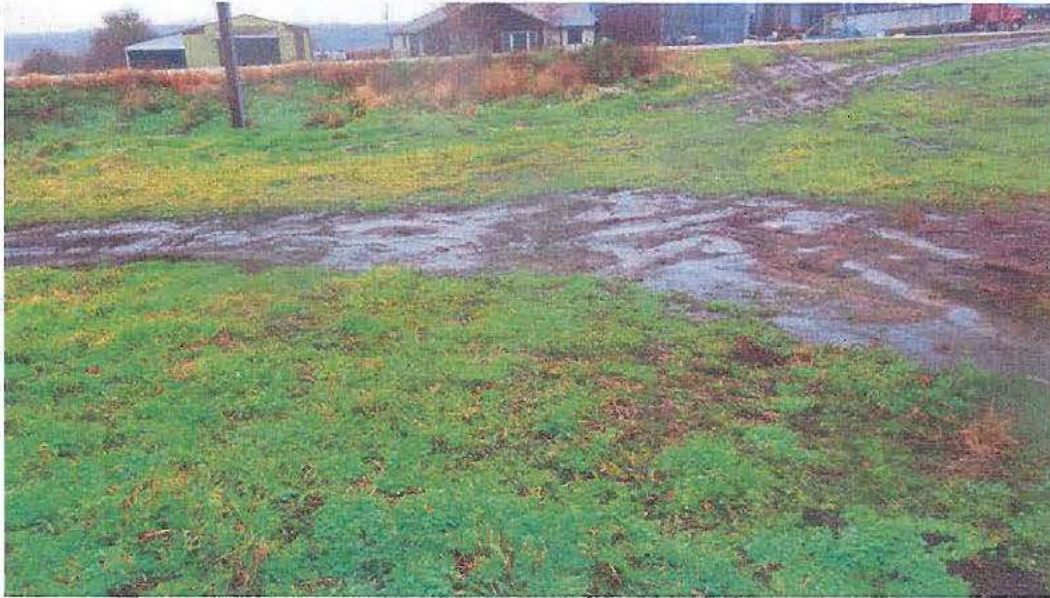
76: RIMG0628

Description: Flow channelization in the yard west of the calf hutches showed that stormwater flowed to the south. The runoff of process wastewater from the feed mixing area and calf hutches would be transported with precipitation in these channels. Note the lack of green vegetation along the pathway.

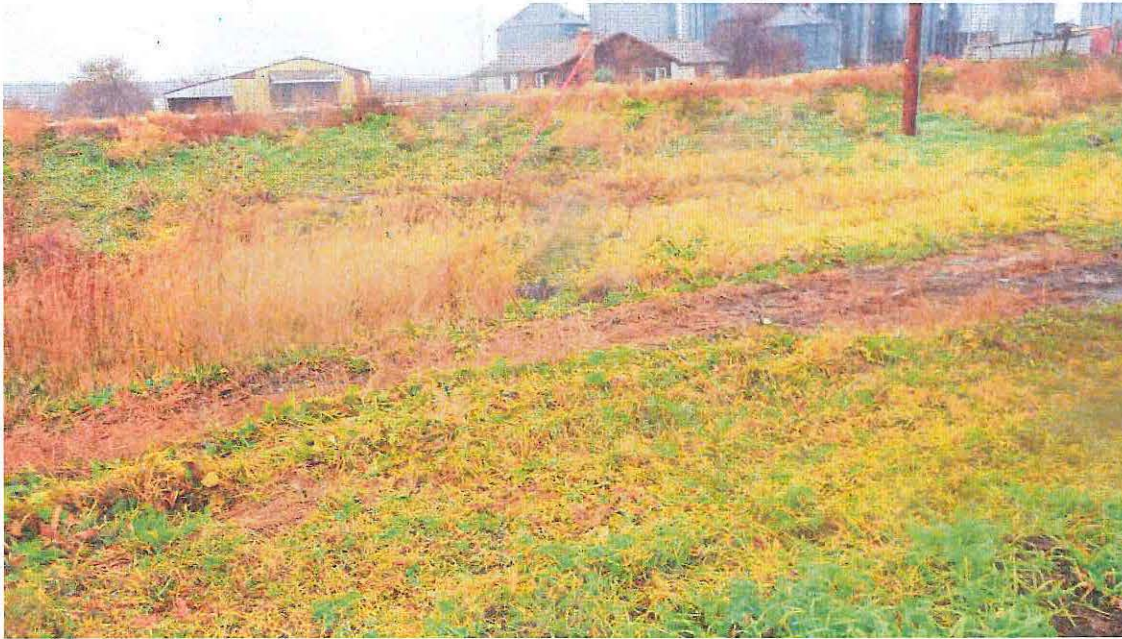
78: RIMG0630

Description: The pathway appeared to be nutrient burned but did not have a continuous flow on the day of the inspection.

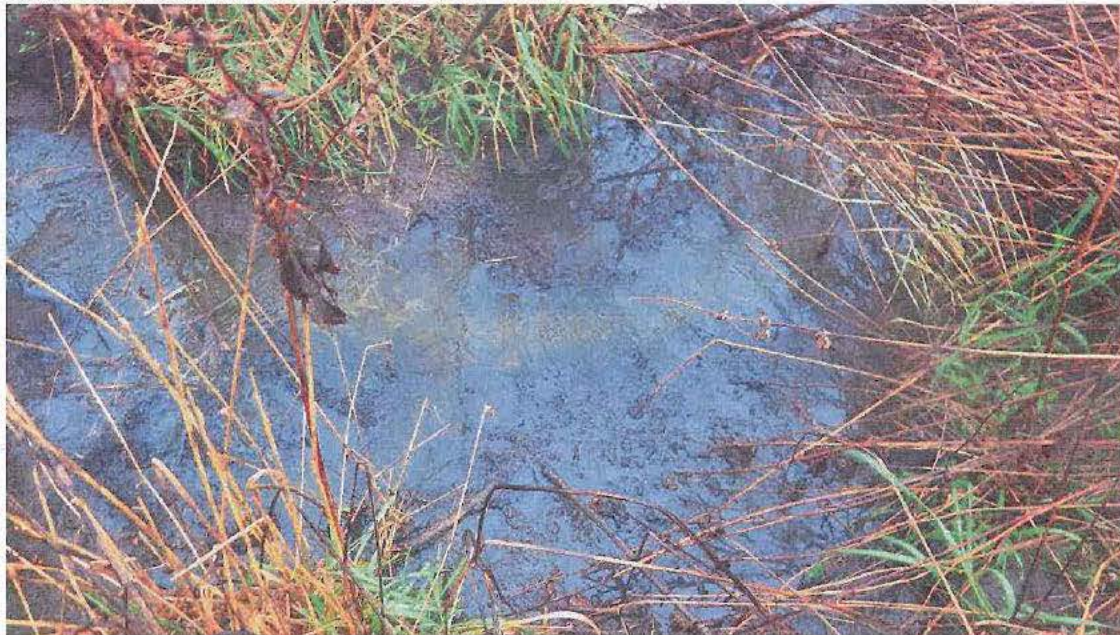
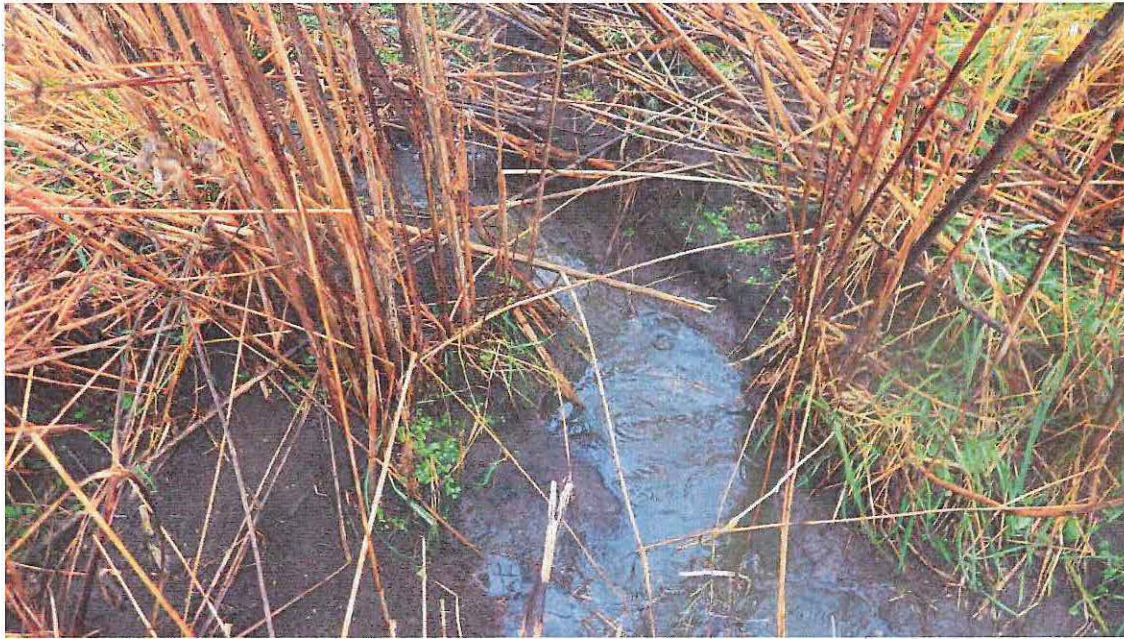
Description: The water in the drainage ditch was dark and full of solids.

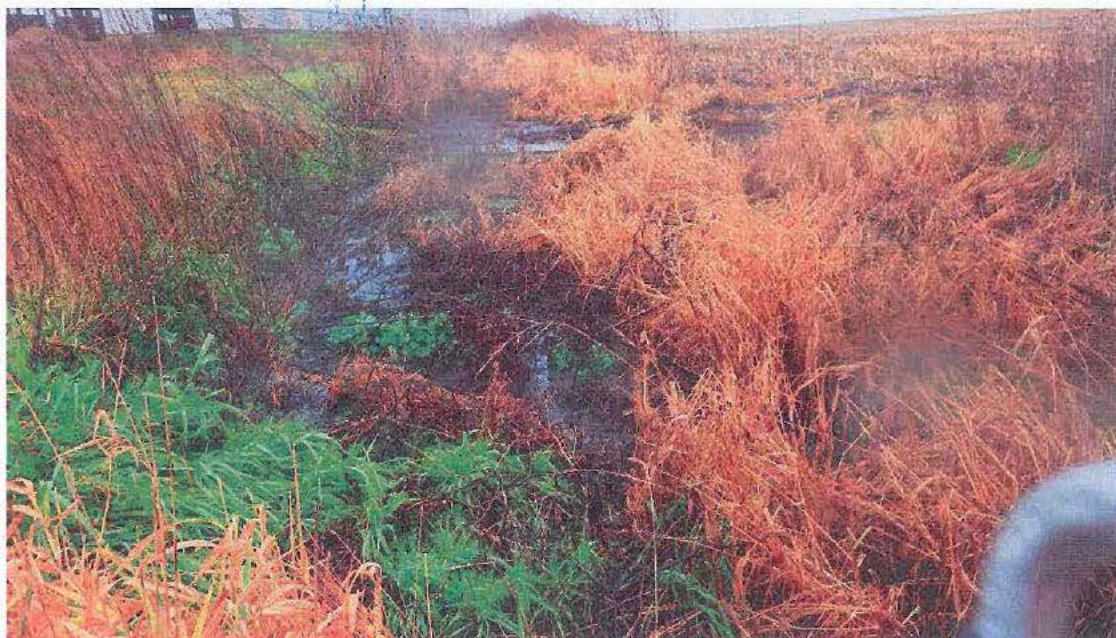
83: RIMG0635

Description: The vegetation along the drainage ditch appeared nutrient burned.

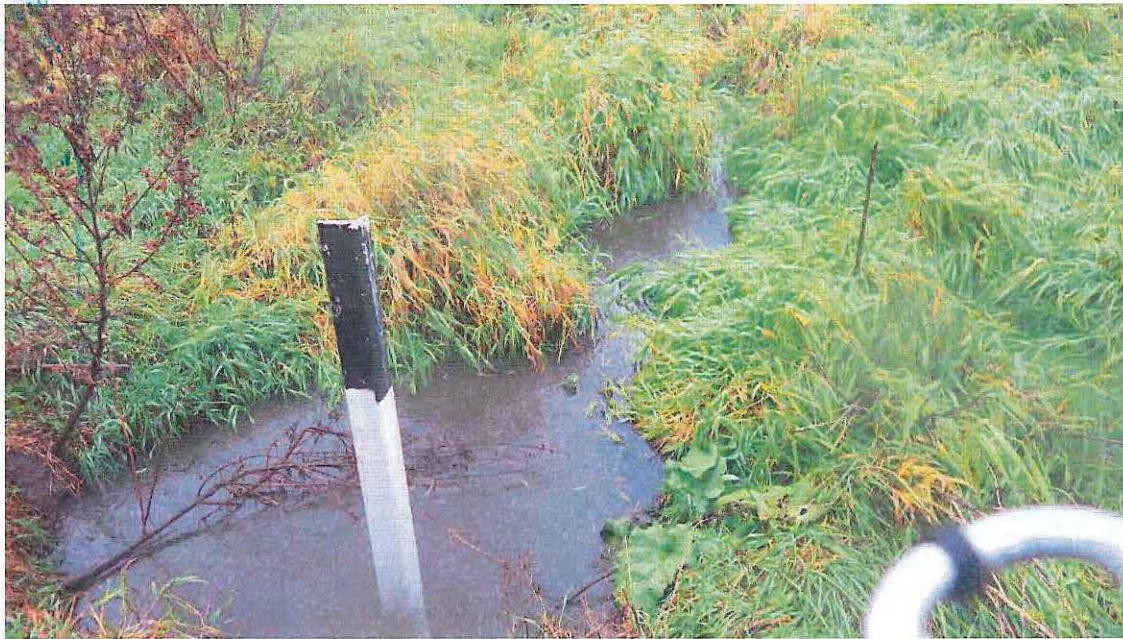
85: RIMG0637

Description: There is a significant amount of flow in the channel after flowing under Wisconsin 120.

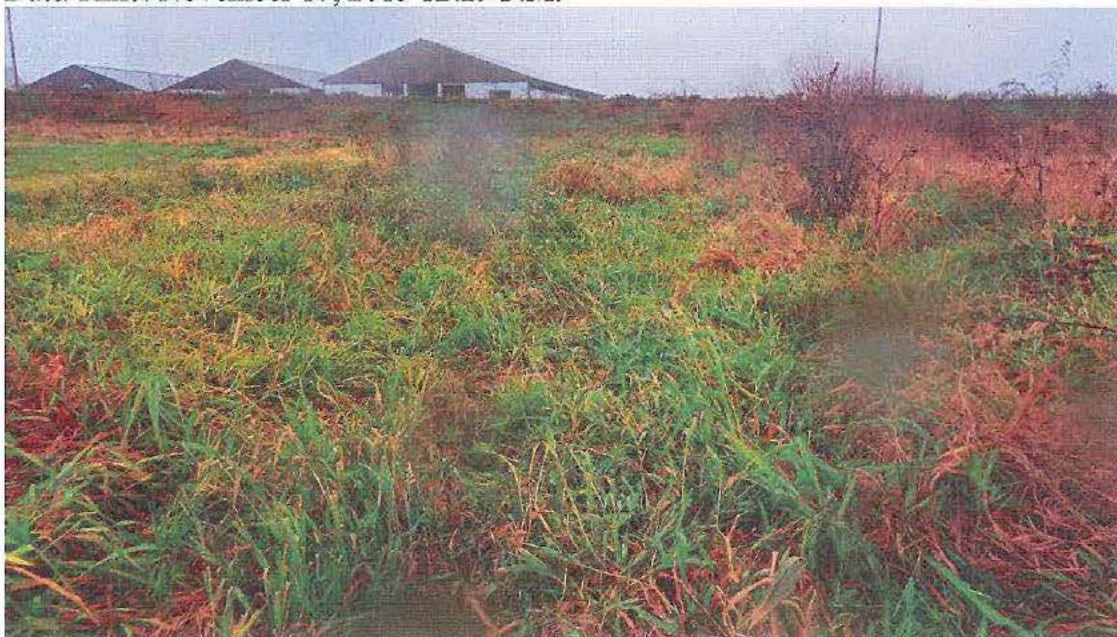
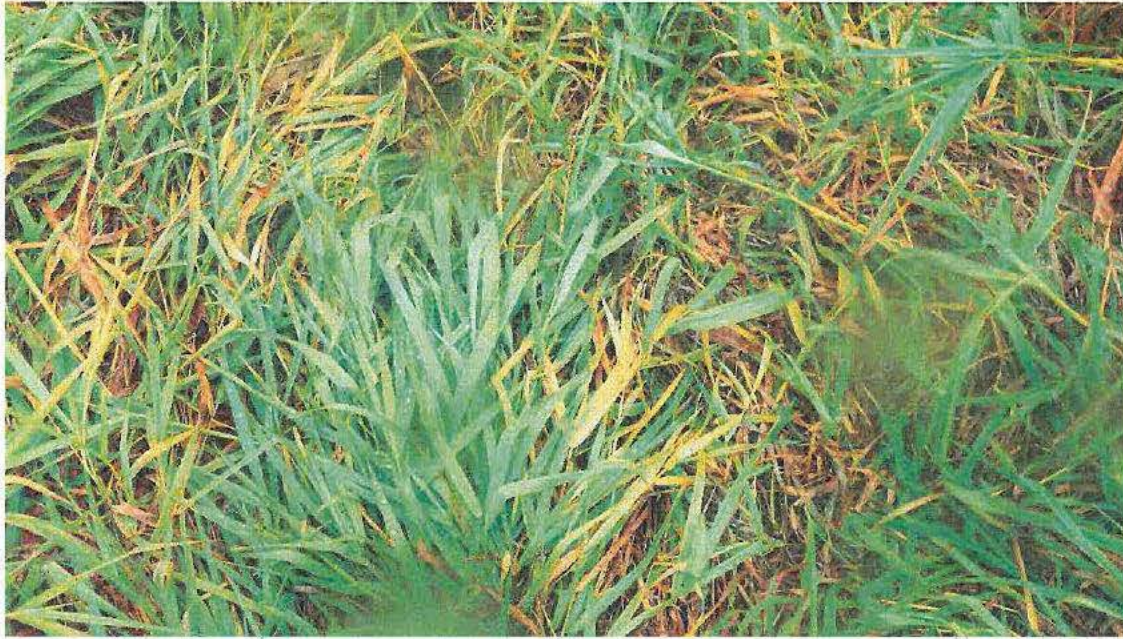
Description: EPA observed flow beneath the vegetation for some distance into the grassed waterway, but then observed that the flow stopped.

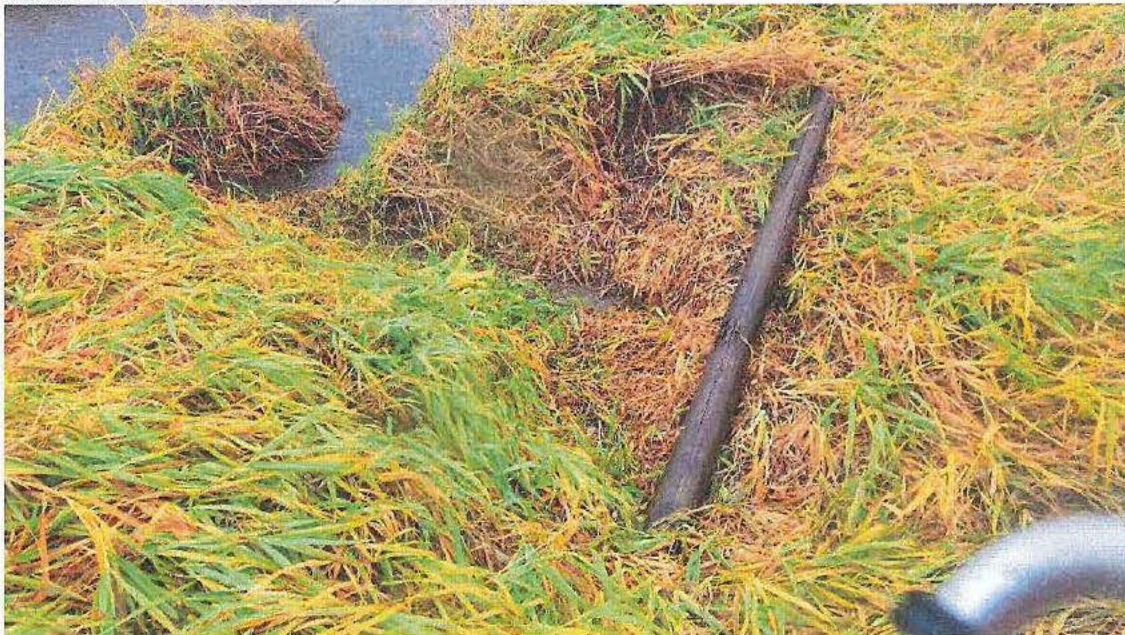
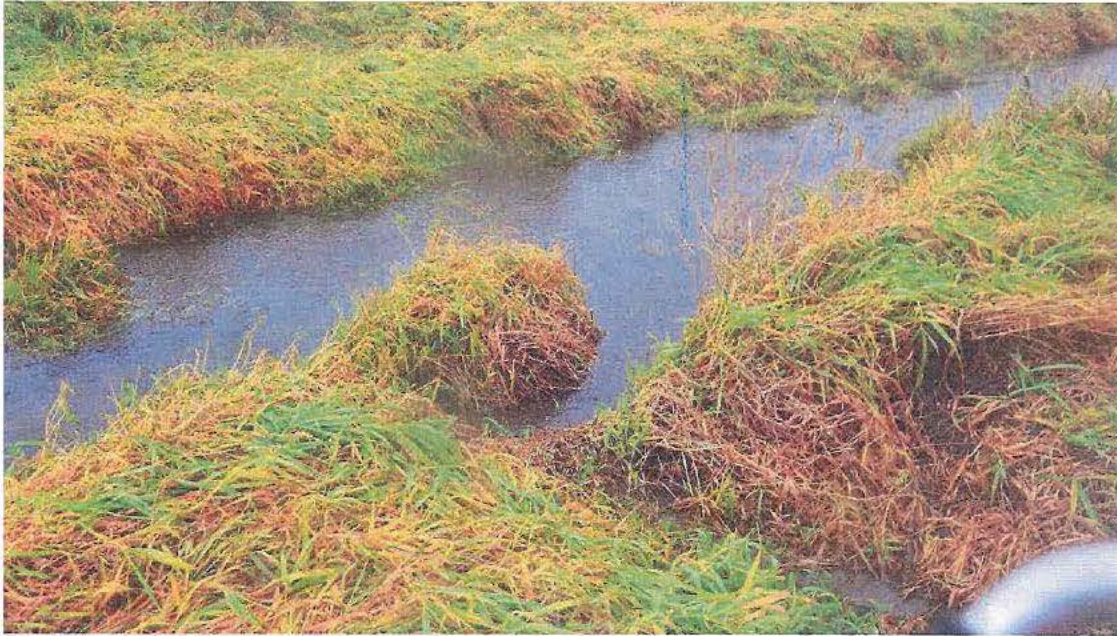
Description: At Nippersink Creek, EPA observed a flow channel from the grassed waterway into the creek.

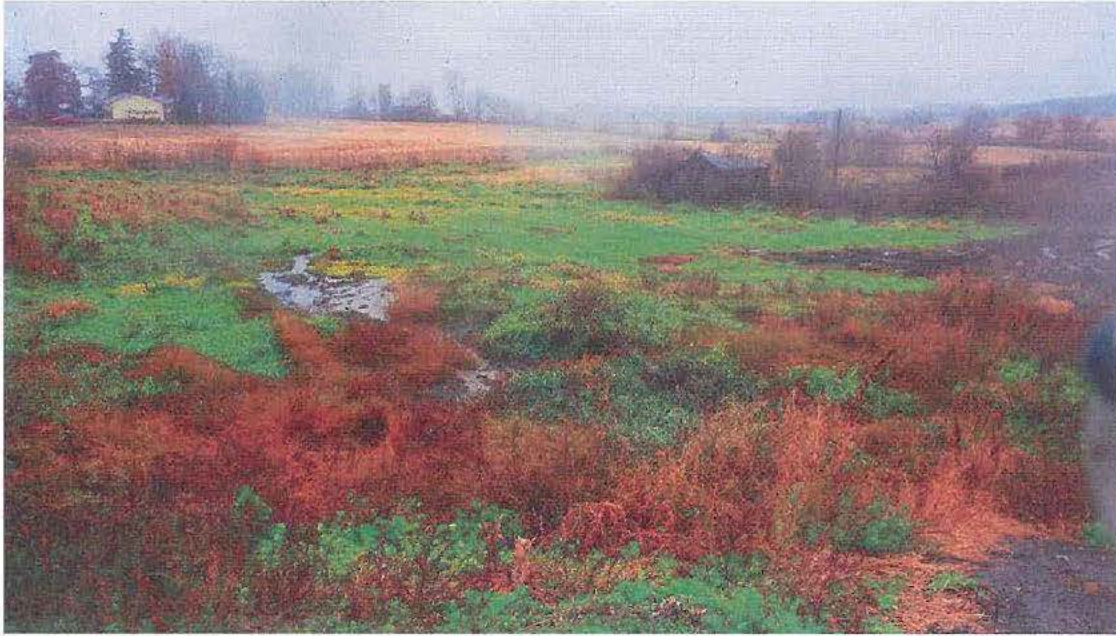
102: RIMG0655

On the west side of Highway 120, there is a storage building with a small area attached that confined a few cattle. Several grain bins and two small heifer barns were also located on this part of the facility. EPA walked to the storage building first and observed that there was no containment for manure, feed or process wastewater from the animal confinement section. EPA documented a runoff pathway from this barn to the south toward the grassed waterway. EPA did not observe this runoff reach a surface waterway on the day of the inspection.

Description: Runoff from the animal confinement area next to the Storage Shed flows to the south toward the grassed waterway.

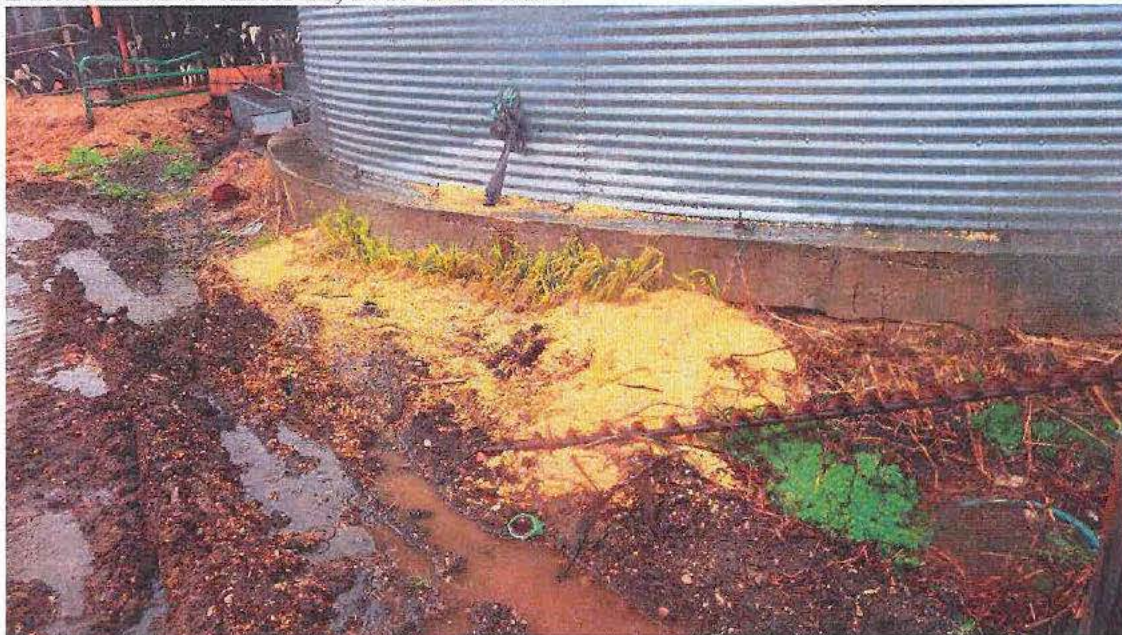
105: RIMG0658

EPA then walked to the north and noted a significant amount of feed on the ground around the grain bins.

Description: Grain spilled on the ground around the grain bins west of Highway 120.
